UNDERWATER BRIDGE INSPECTION REPORT

STRUCTURE NO. 6610

MINNESOTA RIVER

MINNESOTA DEPARTMENT OF TRANSPORTATION
UNDERWATER BRIDGE INSPECTION

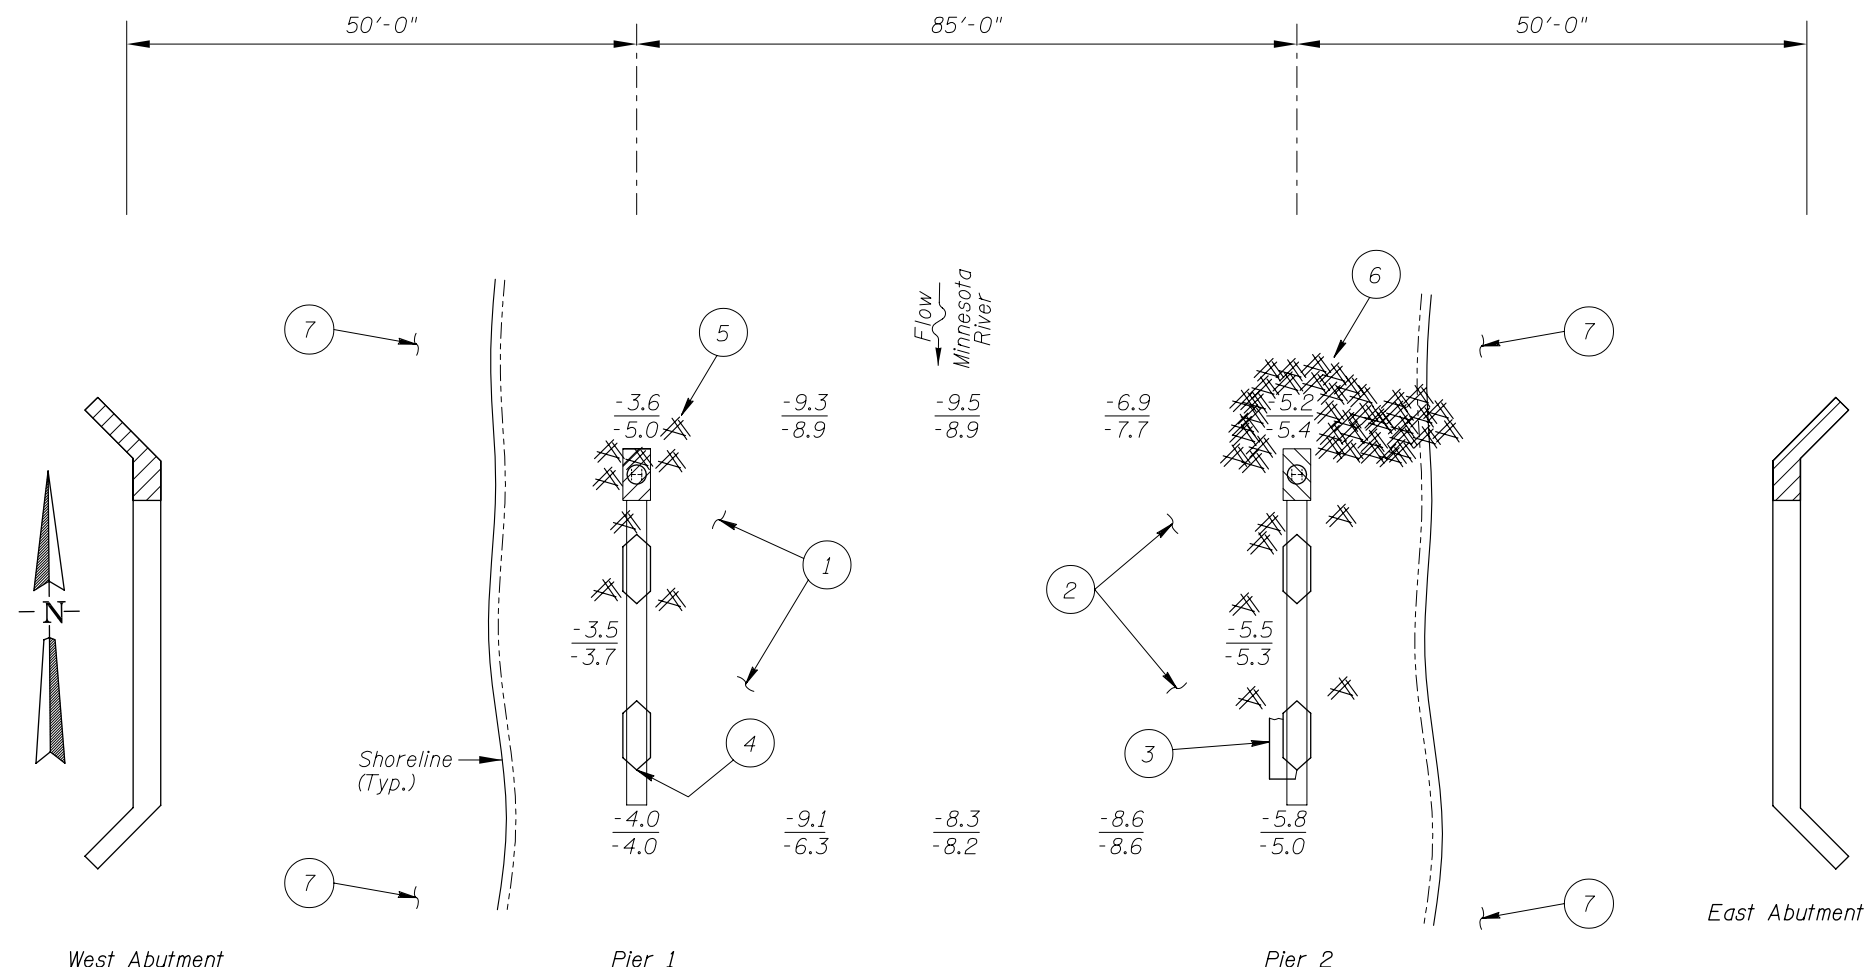
INSPECTION AND SOUNDING PLAN

- 1 The channel bottom material around Pier 1 consisted of a firm sand with approximately 2 inches of probe rod penetration.
- 2 The channel bottom material around Pier 2 consisted of cobbles, 6 inch diameter riprap, and sandy silt with 4 inches of probe rod penetration.

- 3 The footing was exposed at the west side at the downstream column of Pier 2 with a maximum vertical exposure of 3 inches.
- 4 A light area of section loss was observed 2 feet above the waterline at the downstream nose of Pier 1, measuring 3 square inches with 1 inch of penetration.

- 5 A light accumulation of timber debris, consisting of 6 to 8 inch diameter branches, was observed at the upstream nose of Pier 1 and extended along both sides of the pier.

- 6 A heavy accumulation of timber debris, consisting of up to 3 foot diameter timber logs, was observed at the upstream nose of Pier 2 and extended to the shoreline, and a light accumulation of timber debris extended along both sides of the pier.

- 7 Heavy bank erosion resulting in vertical slopes upstream and downstream of the structure on the east and west banks. Banks are well protected at structure with up to 2 foot diameter riprap and concrete revetment. The west embankment protection was covered with silty sand.

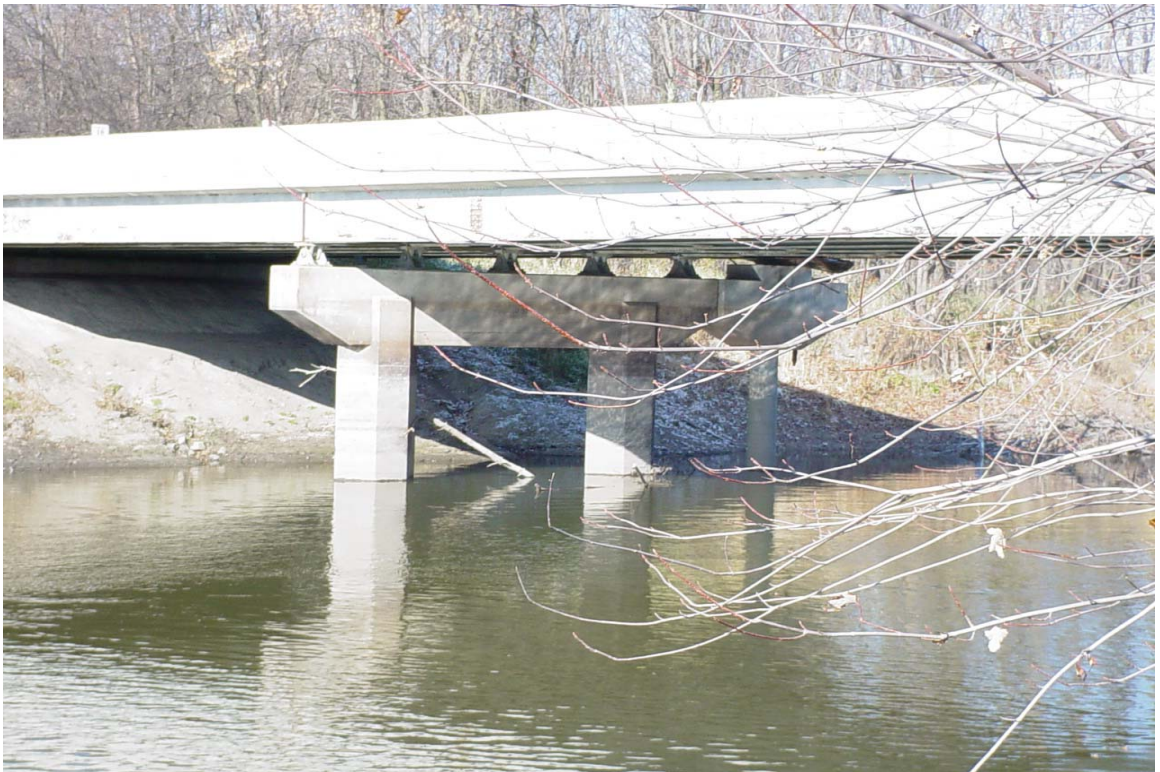
Photograph 2. View of Pier 1, Looking Northwest.

- (A) Remove the accumulations of timber debris from the piers during routine maintenance to prevent further build-up and to restrict scour influence.
- (B) Because the bridge has been evaluated to be scour critical, specifically monitor the footing exposure during future inspections and after periods of high flows.
- (C) Reinspect the submerged substructure units at the normal maximum recommended (NBIS) interval of five (5) years.

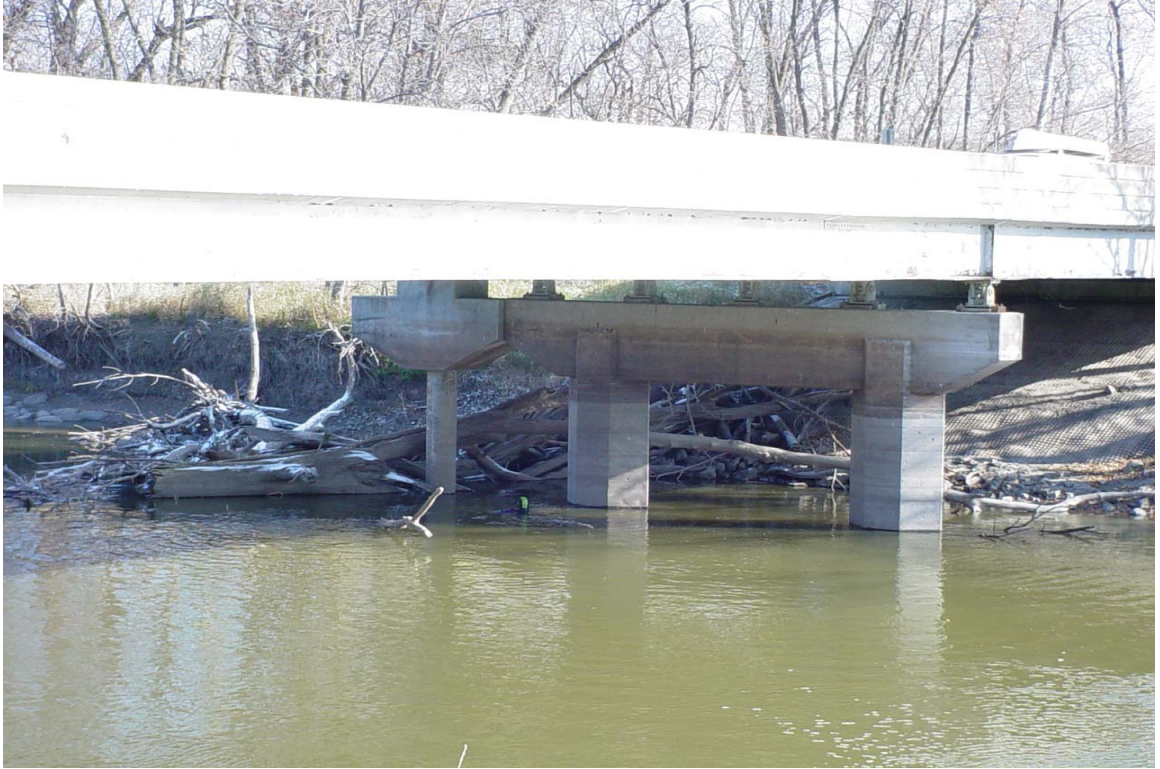
Photograph 3. View of Pier 2, Looking Northeast.

Because the bridge has been evaluated to be scour critical, specifically monitor the footing exposure during future inspections and after periods of high flows.

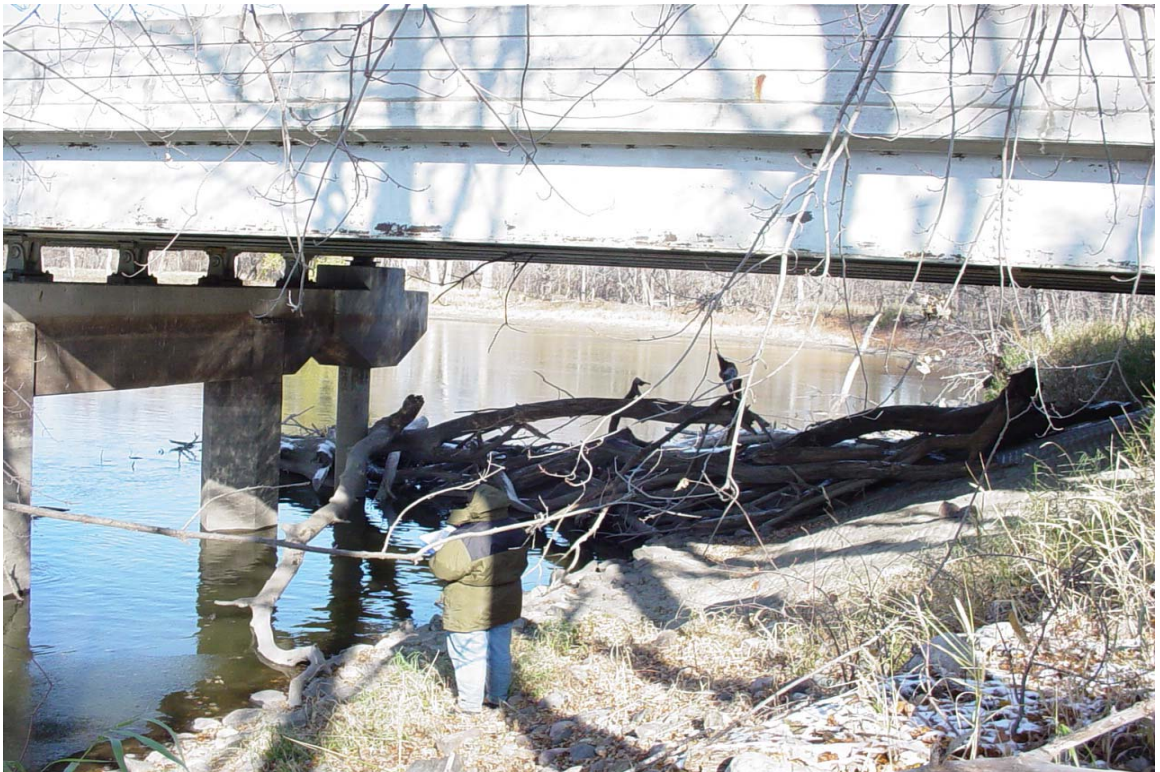
Photograph 4. View of Timber Debris at the Upstream Nose of Pier 2, Looking Northwest.

Remove the accumulations of timber from the piers during routine maintenance to prevent further build-up and to restrict scour influence.

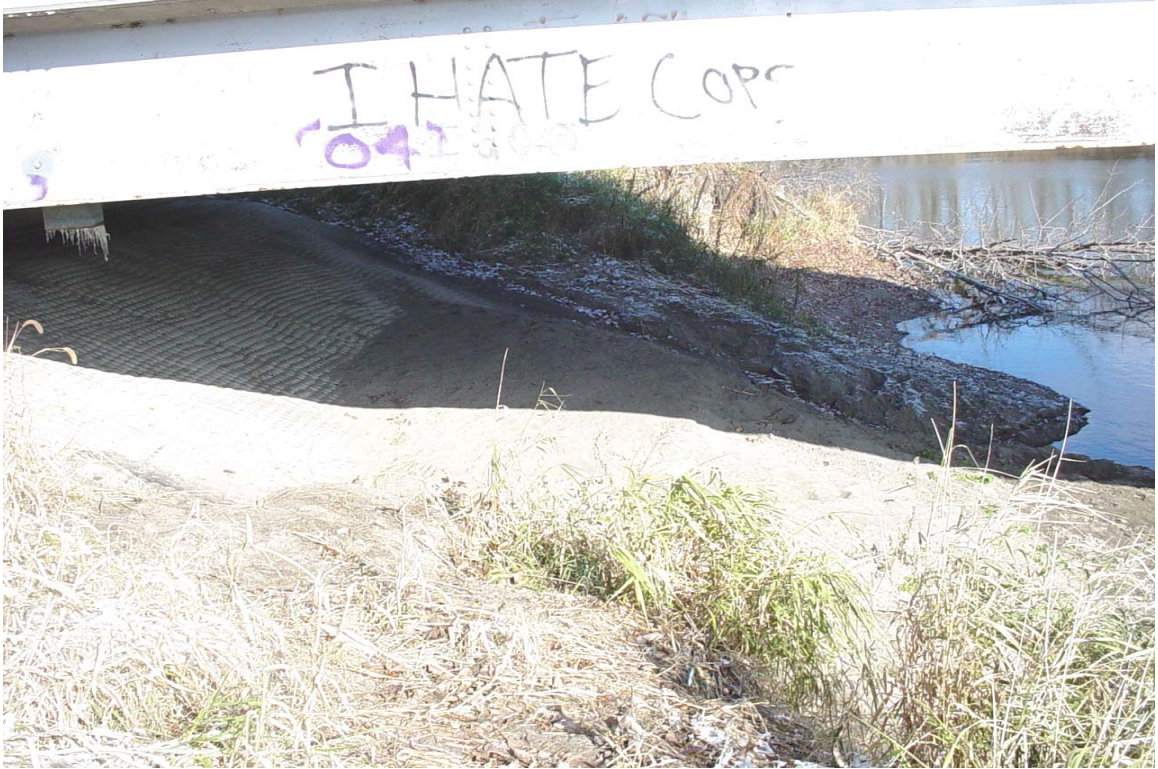
Photograph 5. View of West Bank, Looking North.

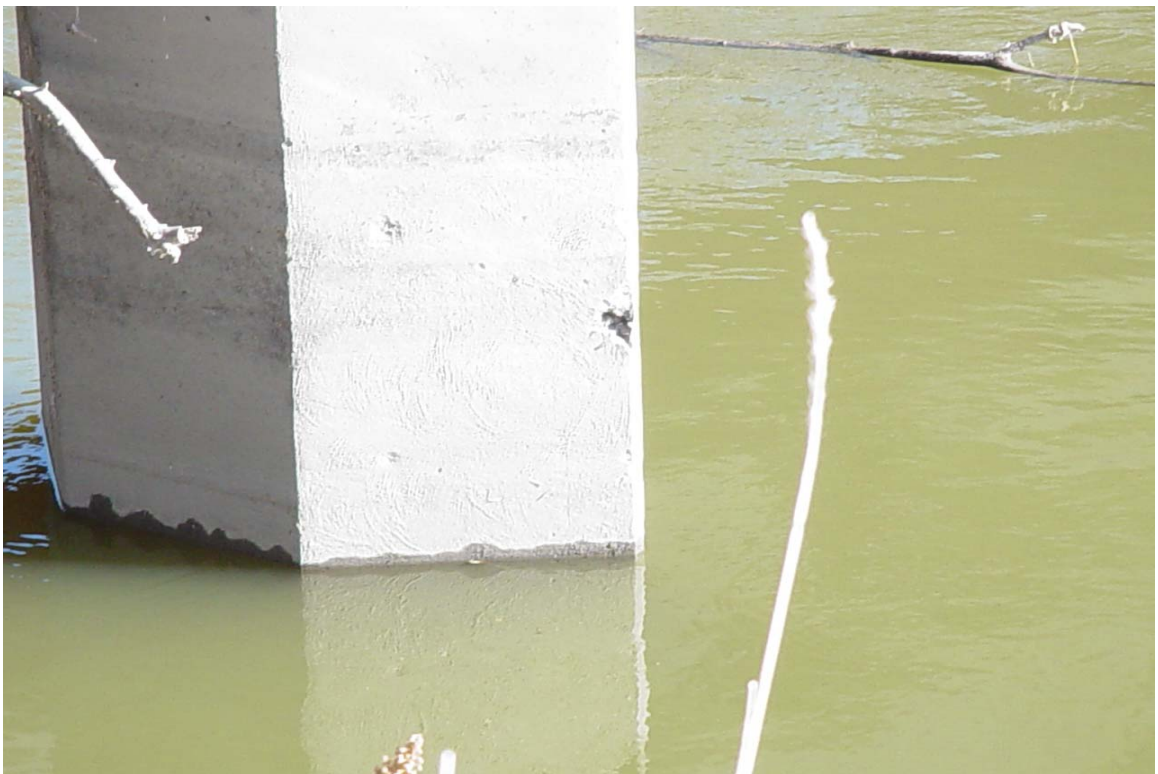
Photograph 6. View of Downstream Nose of Pier 1, Looking Northeast.
